Land Subsidence Rate in the Northeast Phoenix and Scottsdale Areas, Maricopa County Based on Radarsat-2 Satellite Interferometric Synthetic Aperture Radar (InSAR) Data

Time Period of Analysis: 1.0 Years 05/22/2021 To 05/17/2022

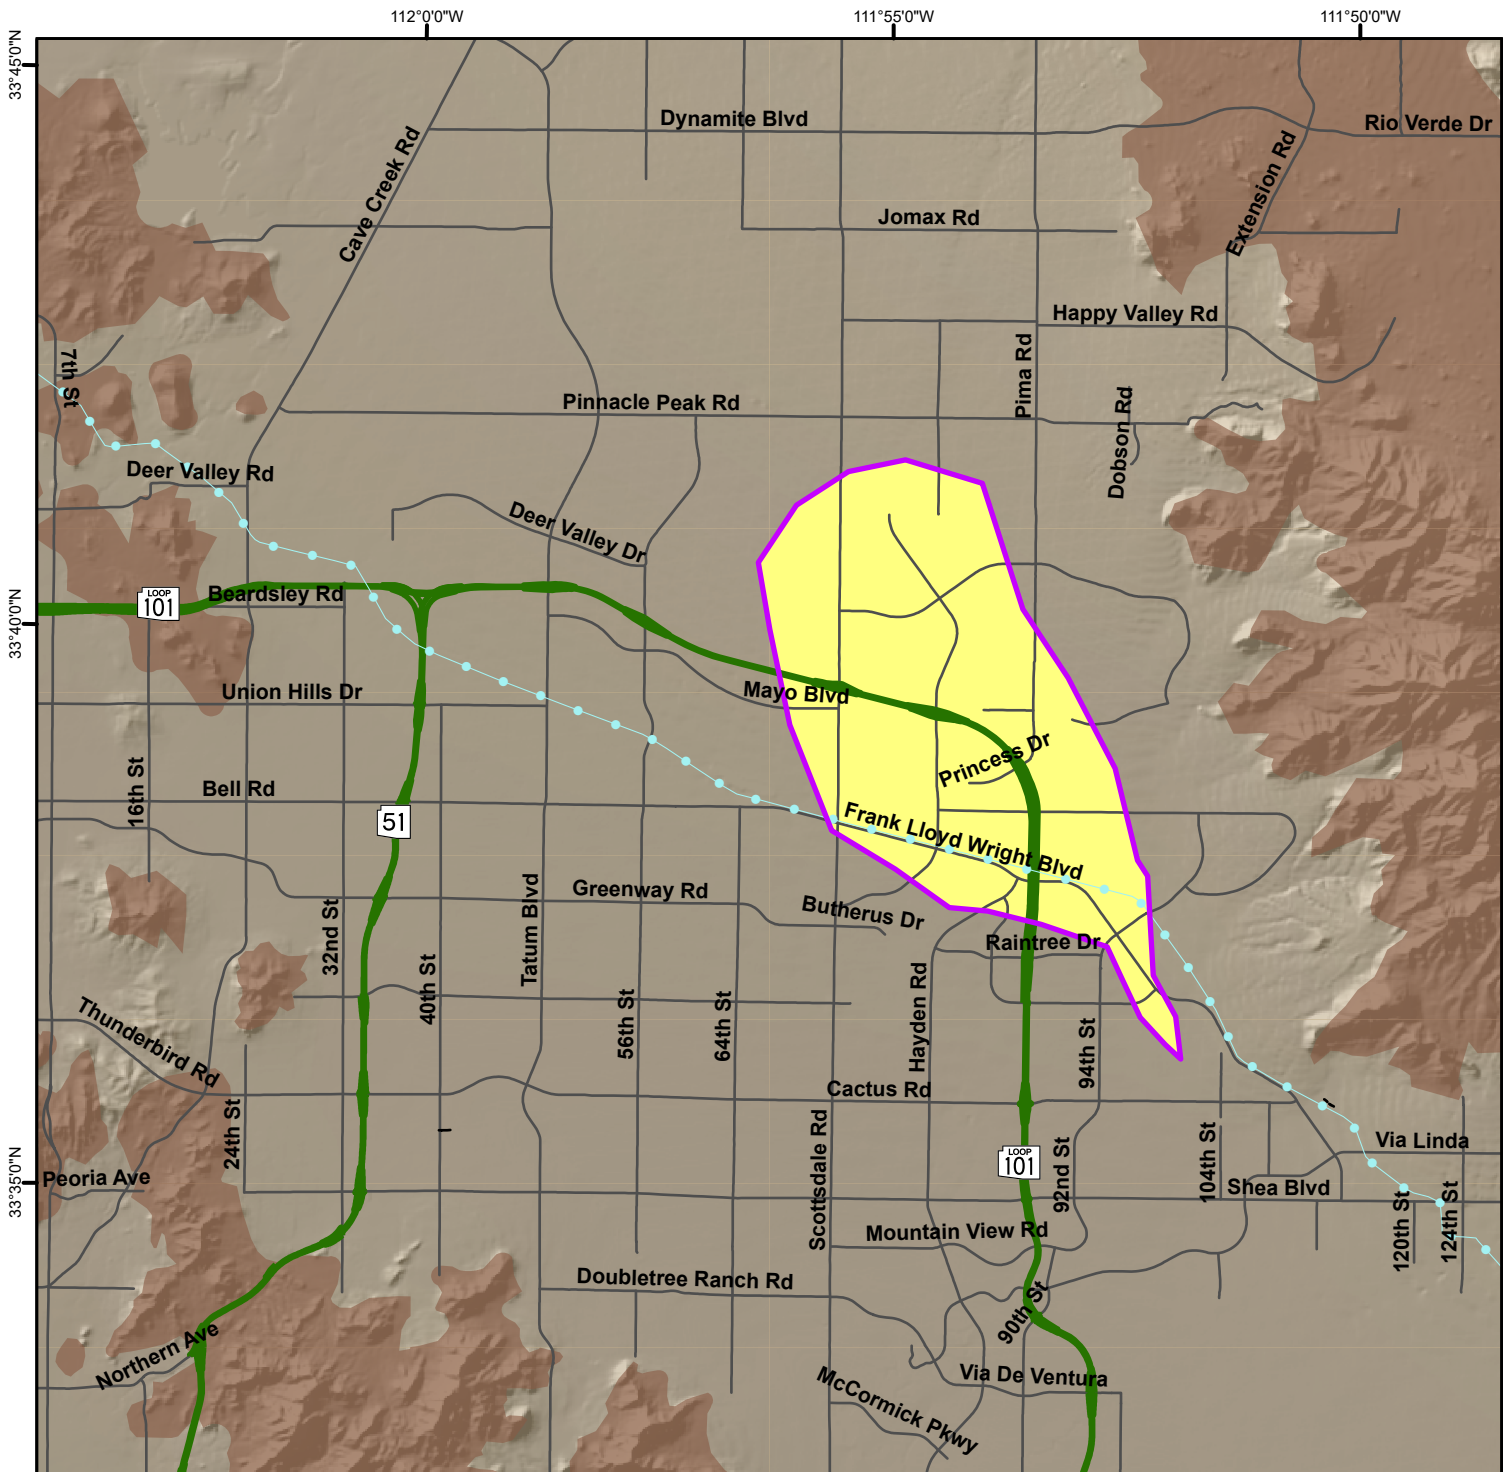
Decorrelation (white areas) are areas where the phase of the received satellite signal changed between satellite passes, causing the data to be unusable. This occurs in areas where the land surface has been disturbed (i.e. bodies of water, snow, agriculture areas, areas of development, etc).
